GIANT FOREST  
**SEQUOIA**

**A Historical and Architectural Study of  
Three Rustic Structures at Giant Forest in Sequoia National Park  
The Market, District Ranger's Residence, and Comfort Station**

**HISTORIC STRUCTURES REPORT  
SEQUOIA NATIONAL PARK**

Approved  
December 7, 1988

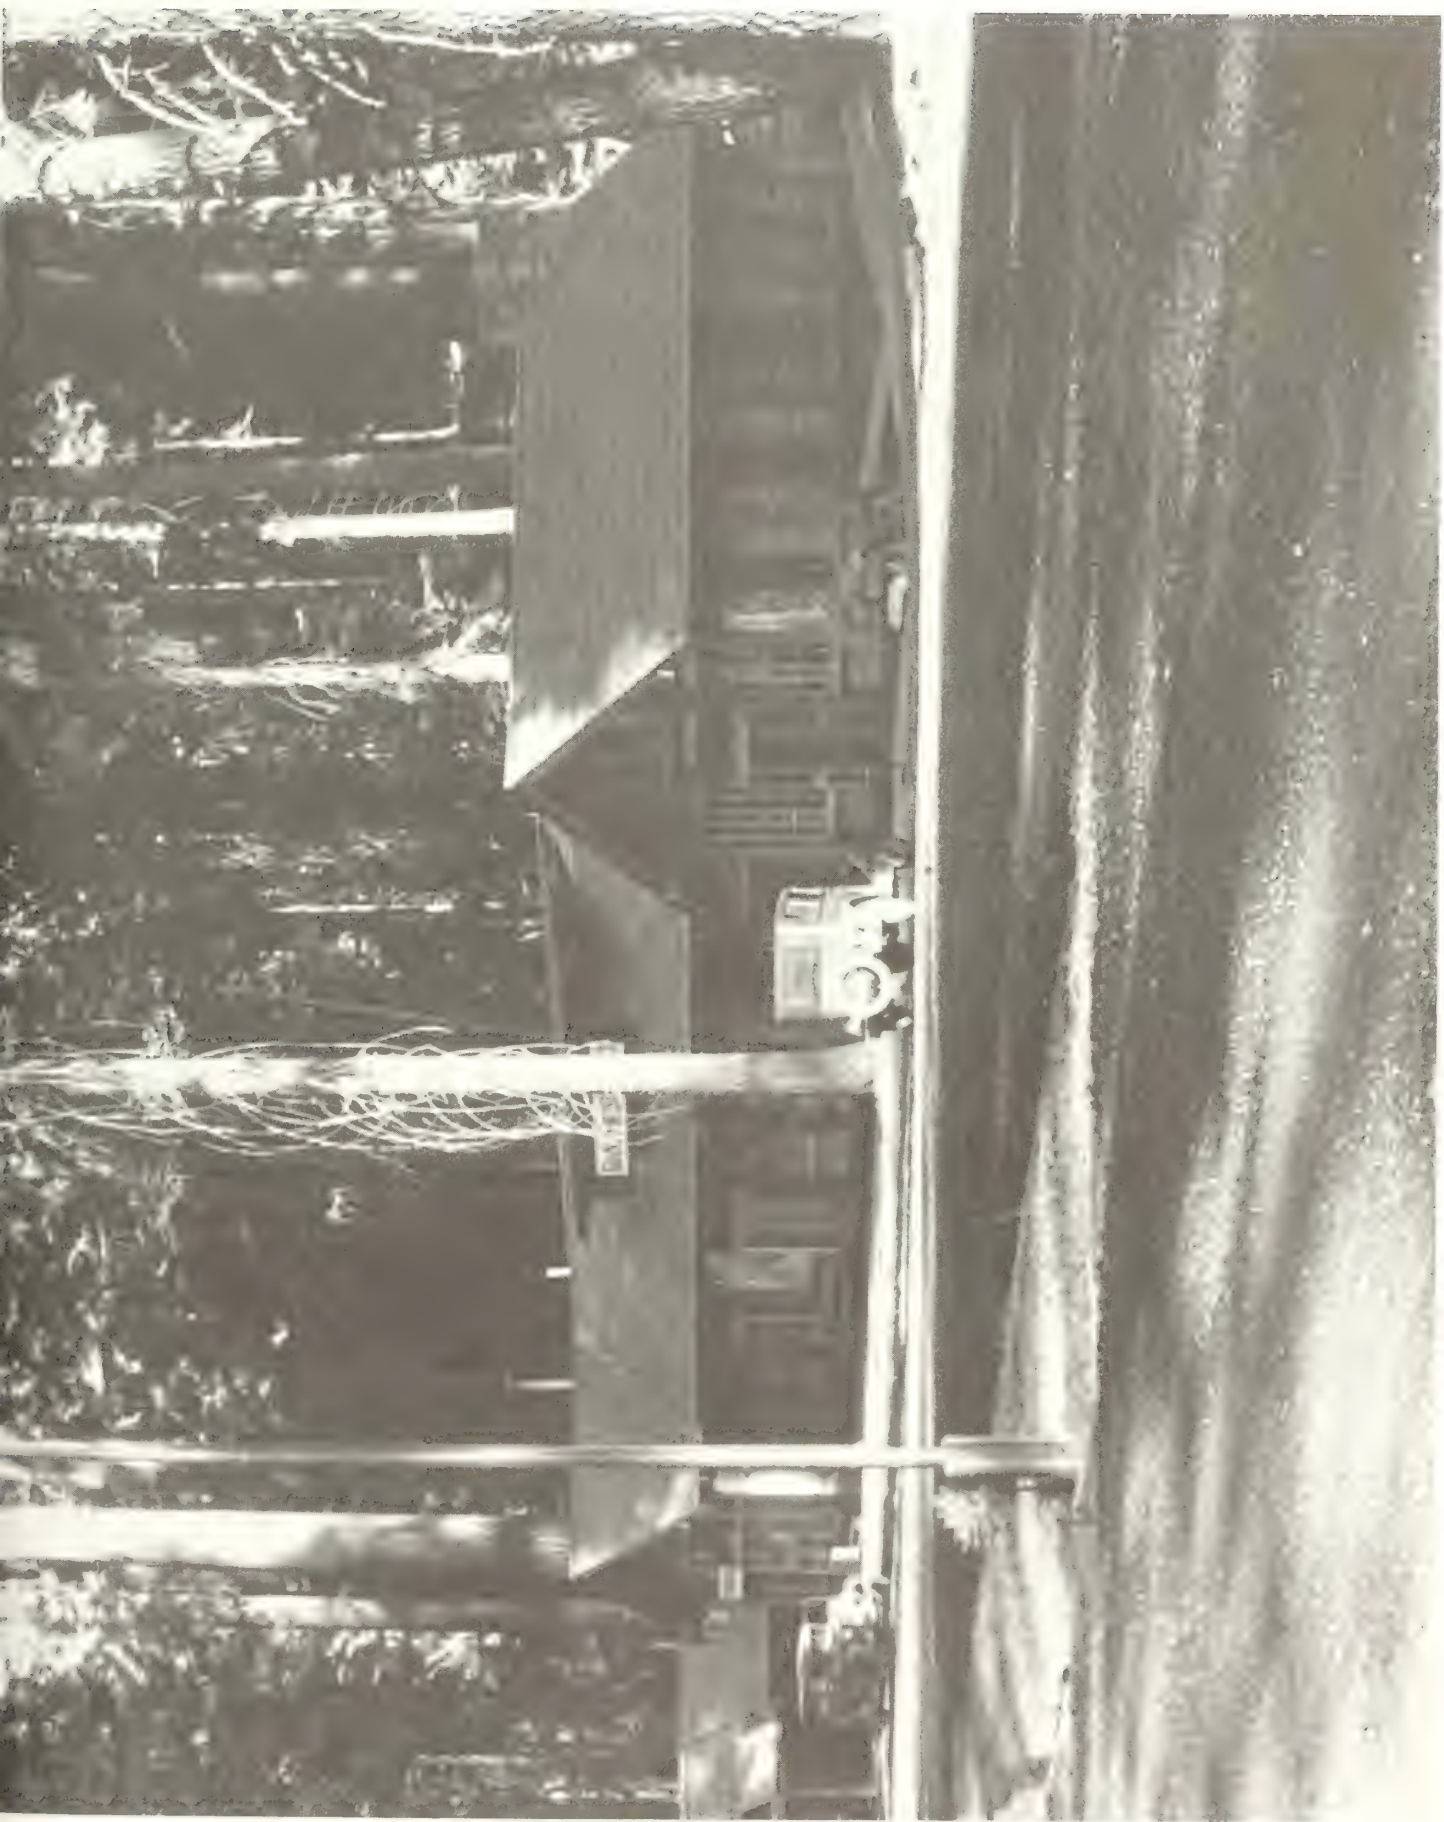
Figure 16. Market, View from Southwest (1932). The remodeling of 1930 produced, in the south wing, a single central entry flanked by windows and created the rest of the south and west facades as they are today. Notice, site grade and earth walk in front and south are much lower than today. Notice, also, double tree at right which is removed later this same year, see figure below. (Photo by Lindley Eddy; SEQU archives #03153)

Figure H-1. South wing of Market (1932). This view is a blow-up of that portion of figure 16 which best illustrates the fenestration of the gable end of the south wing during the 1930s. (Photo by Lindley Eddy; SEQU archives #03153)

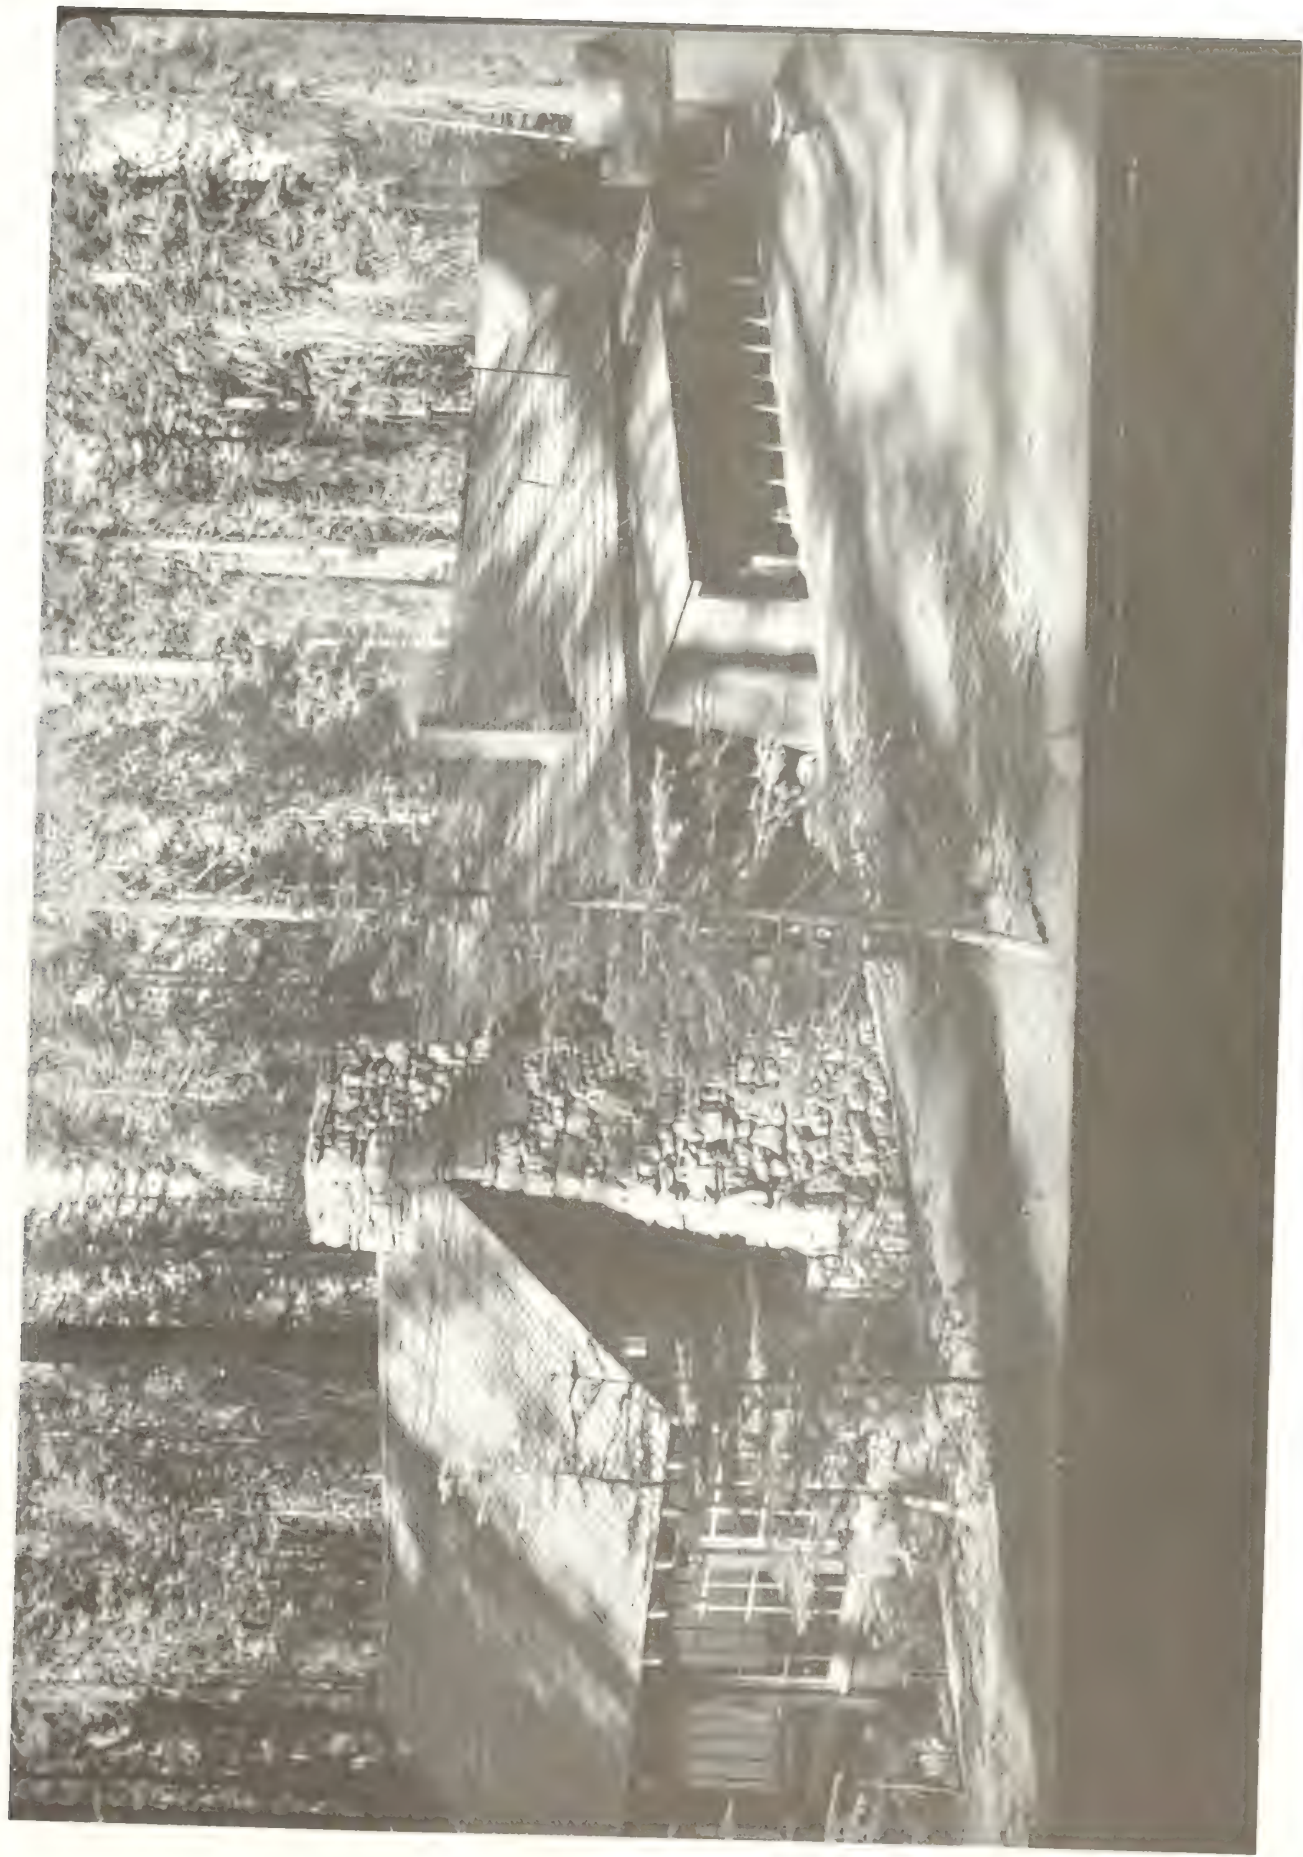
Figure 21. Market, View of Rear (west) Side (1935). This is the first known photograph showing the back of the market and the only known view of the first shed roofed addition. Electric power lines connect at the south wing. A brick chimney is present (no longer extant). The first shed addition appears to be protected along the west by a retaining wall and a door is present at its south end (features proposed in this HSR for installation at the 1938 addition). Notice the level of site grade adjacent to the south facade is much lower than today and probably allows the proper functioning of the crawl space vents which are now buried (Photo by Lloyd Fletcher, SEQU archives #05185).

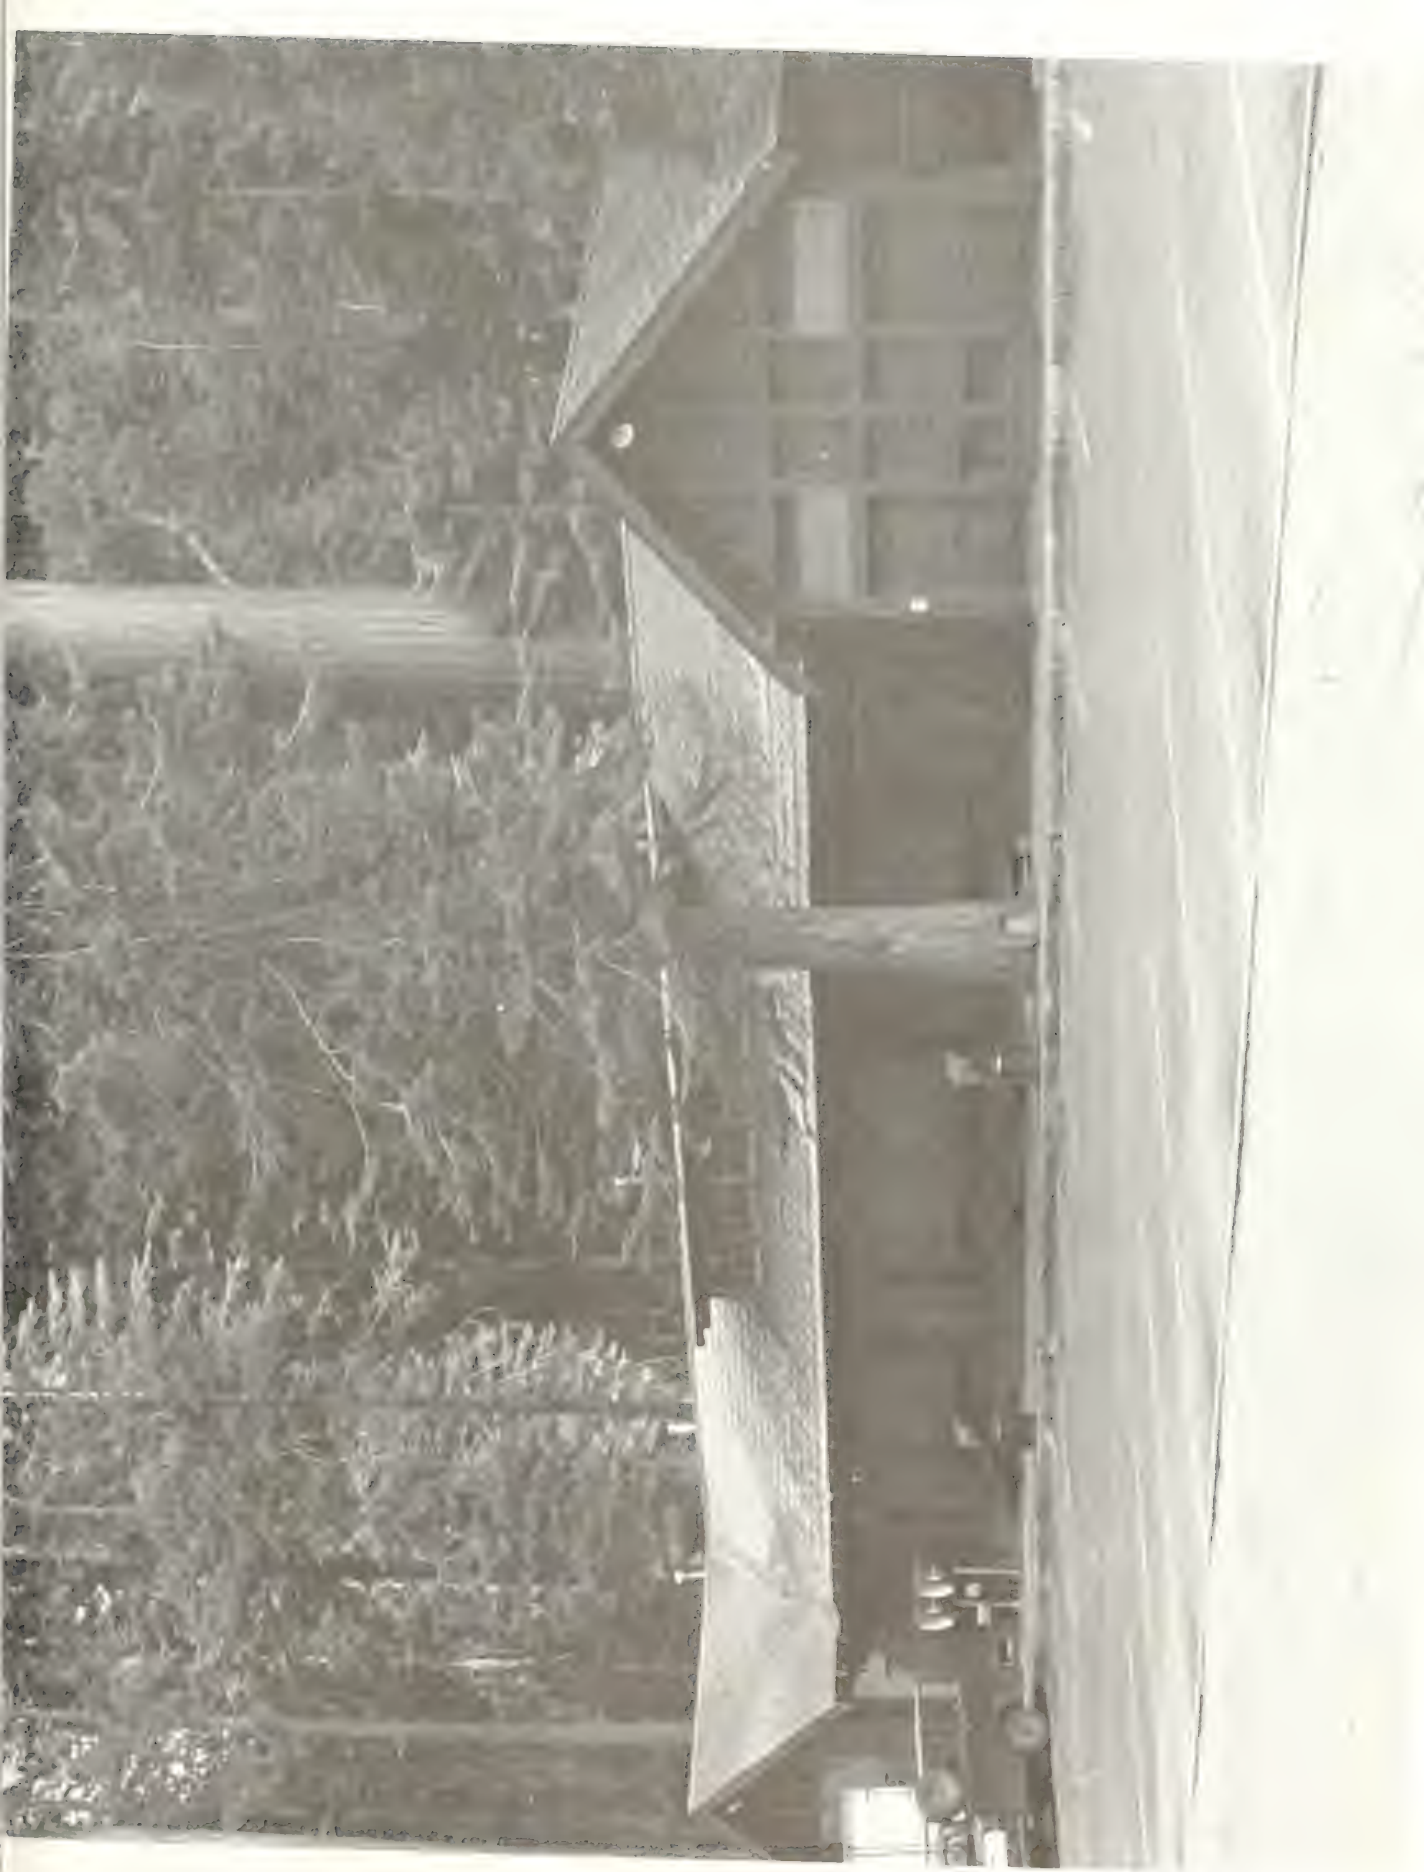
Figure 28. Market, View from West, Southwest (1973). Apparently shut down at this time, this view includes several aspects of interest compared to the previous view (1947): gable end lamps have been relocated to below the roof overhang; signs are gone; wooden ramps approach two doors; and the deteriorated roof is a major subject of the 1973 photographs. Of note is the partial replacement of shake roofing with wooden shingles at the north end. (Photo by Bill Jones, SEQU archive collections)

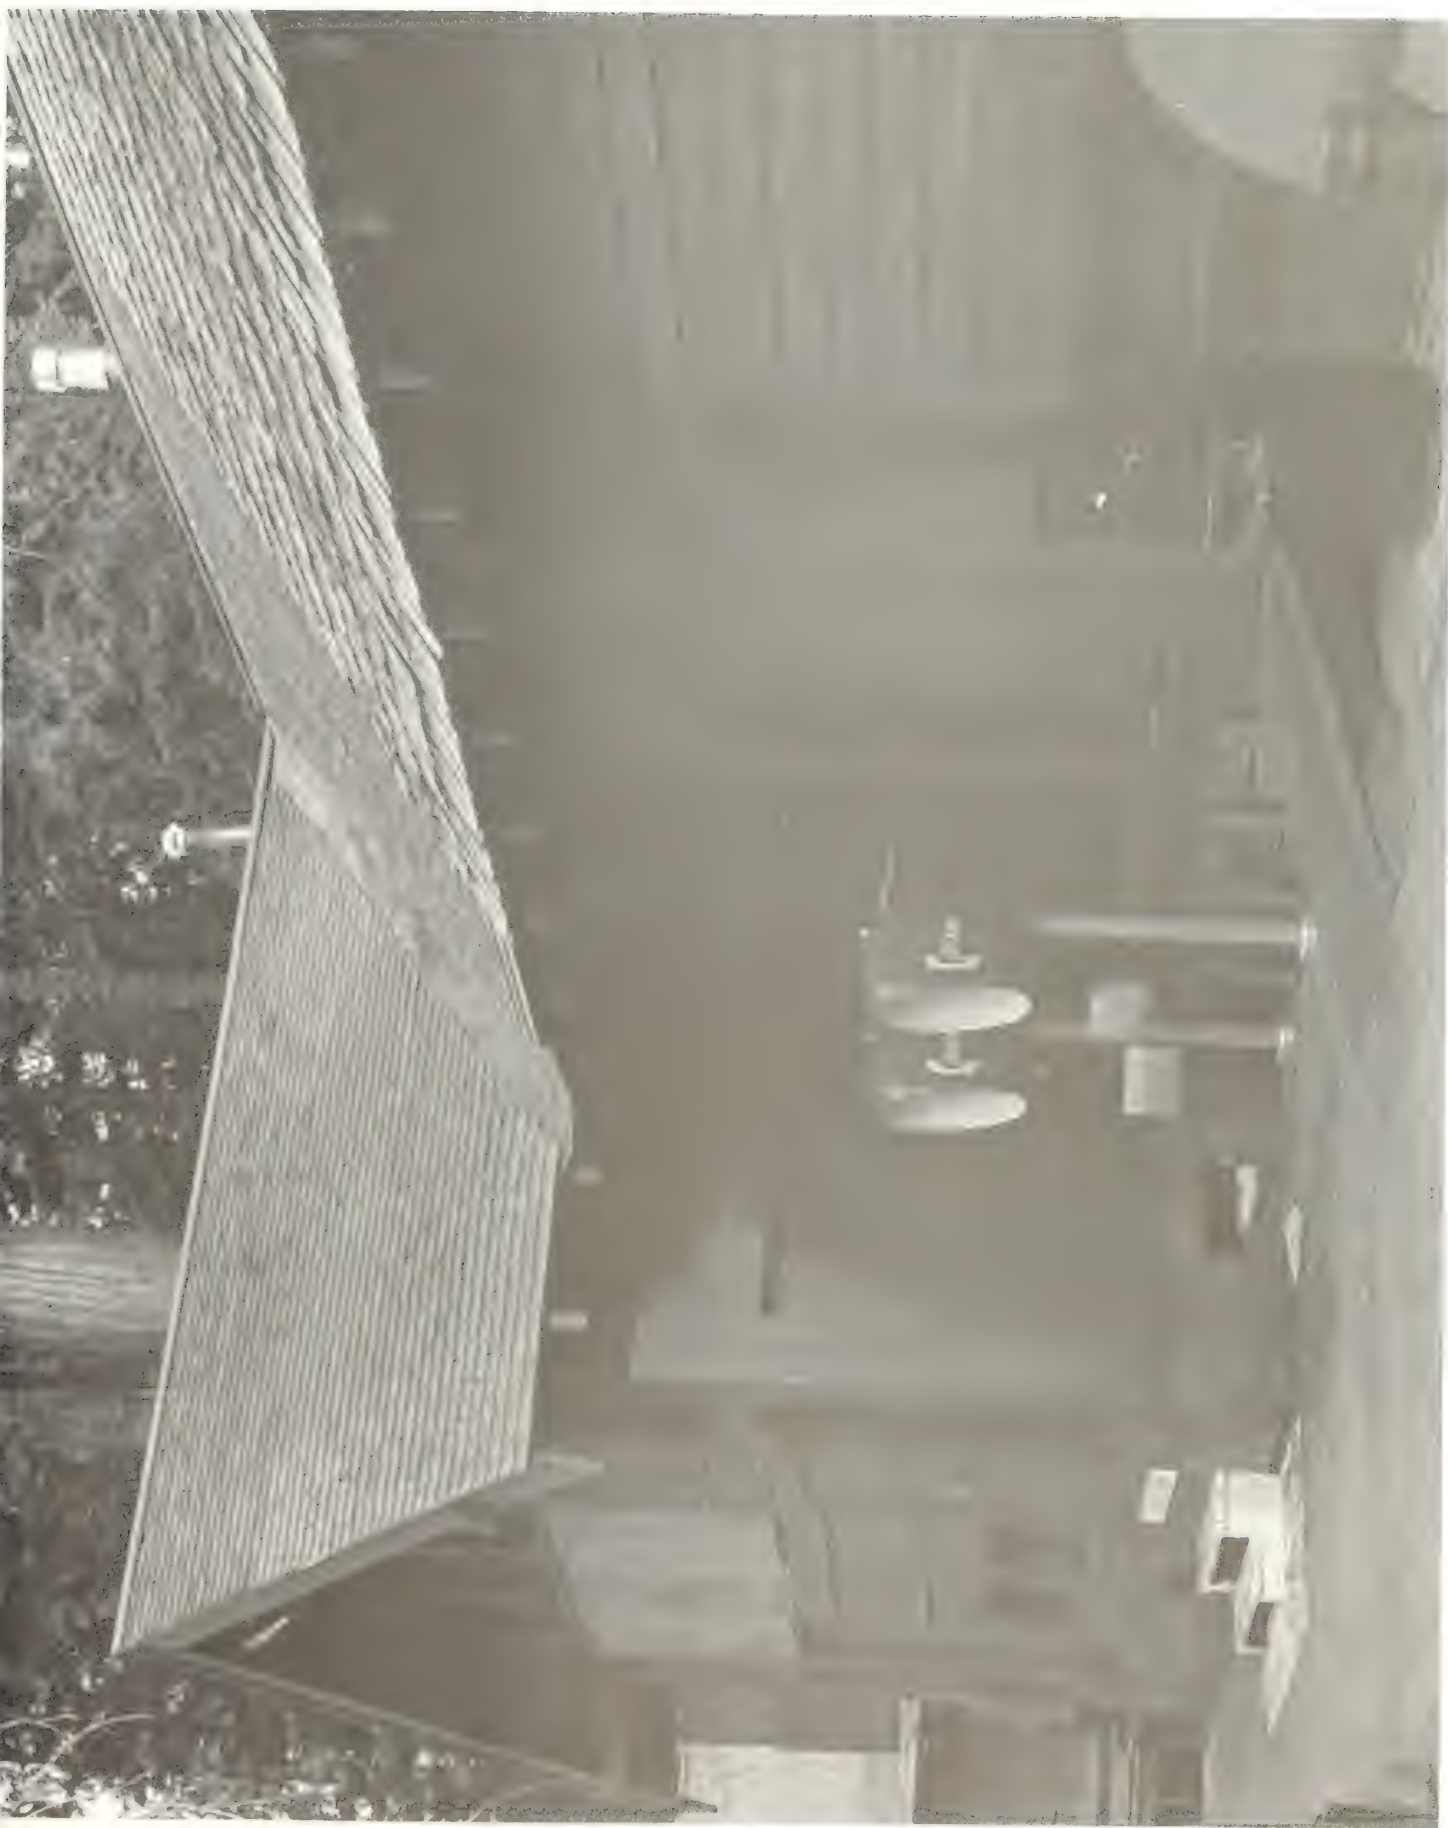
Figure 30. Market Detail (1973). Concrete pads were placed for trash can, telephone and stair bases. Notice ramp to door not presently in use. This detail shows a portion of the shakes replaced with wood shingles; a significant textural change. (Photo by Bill Jones, SEQU archive collection)

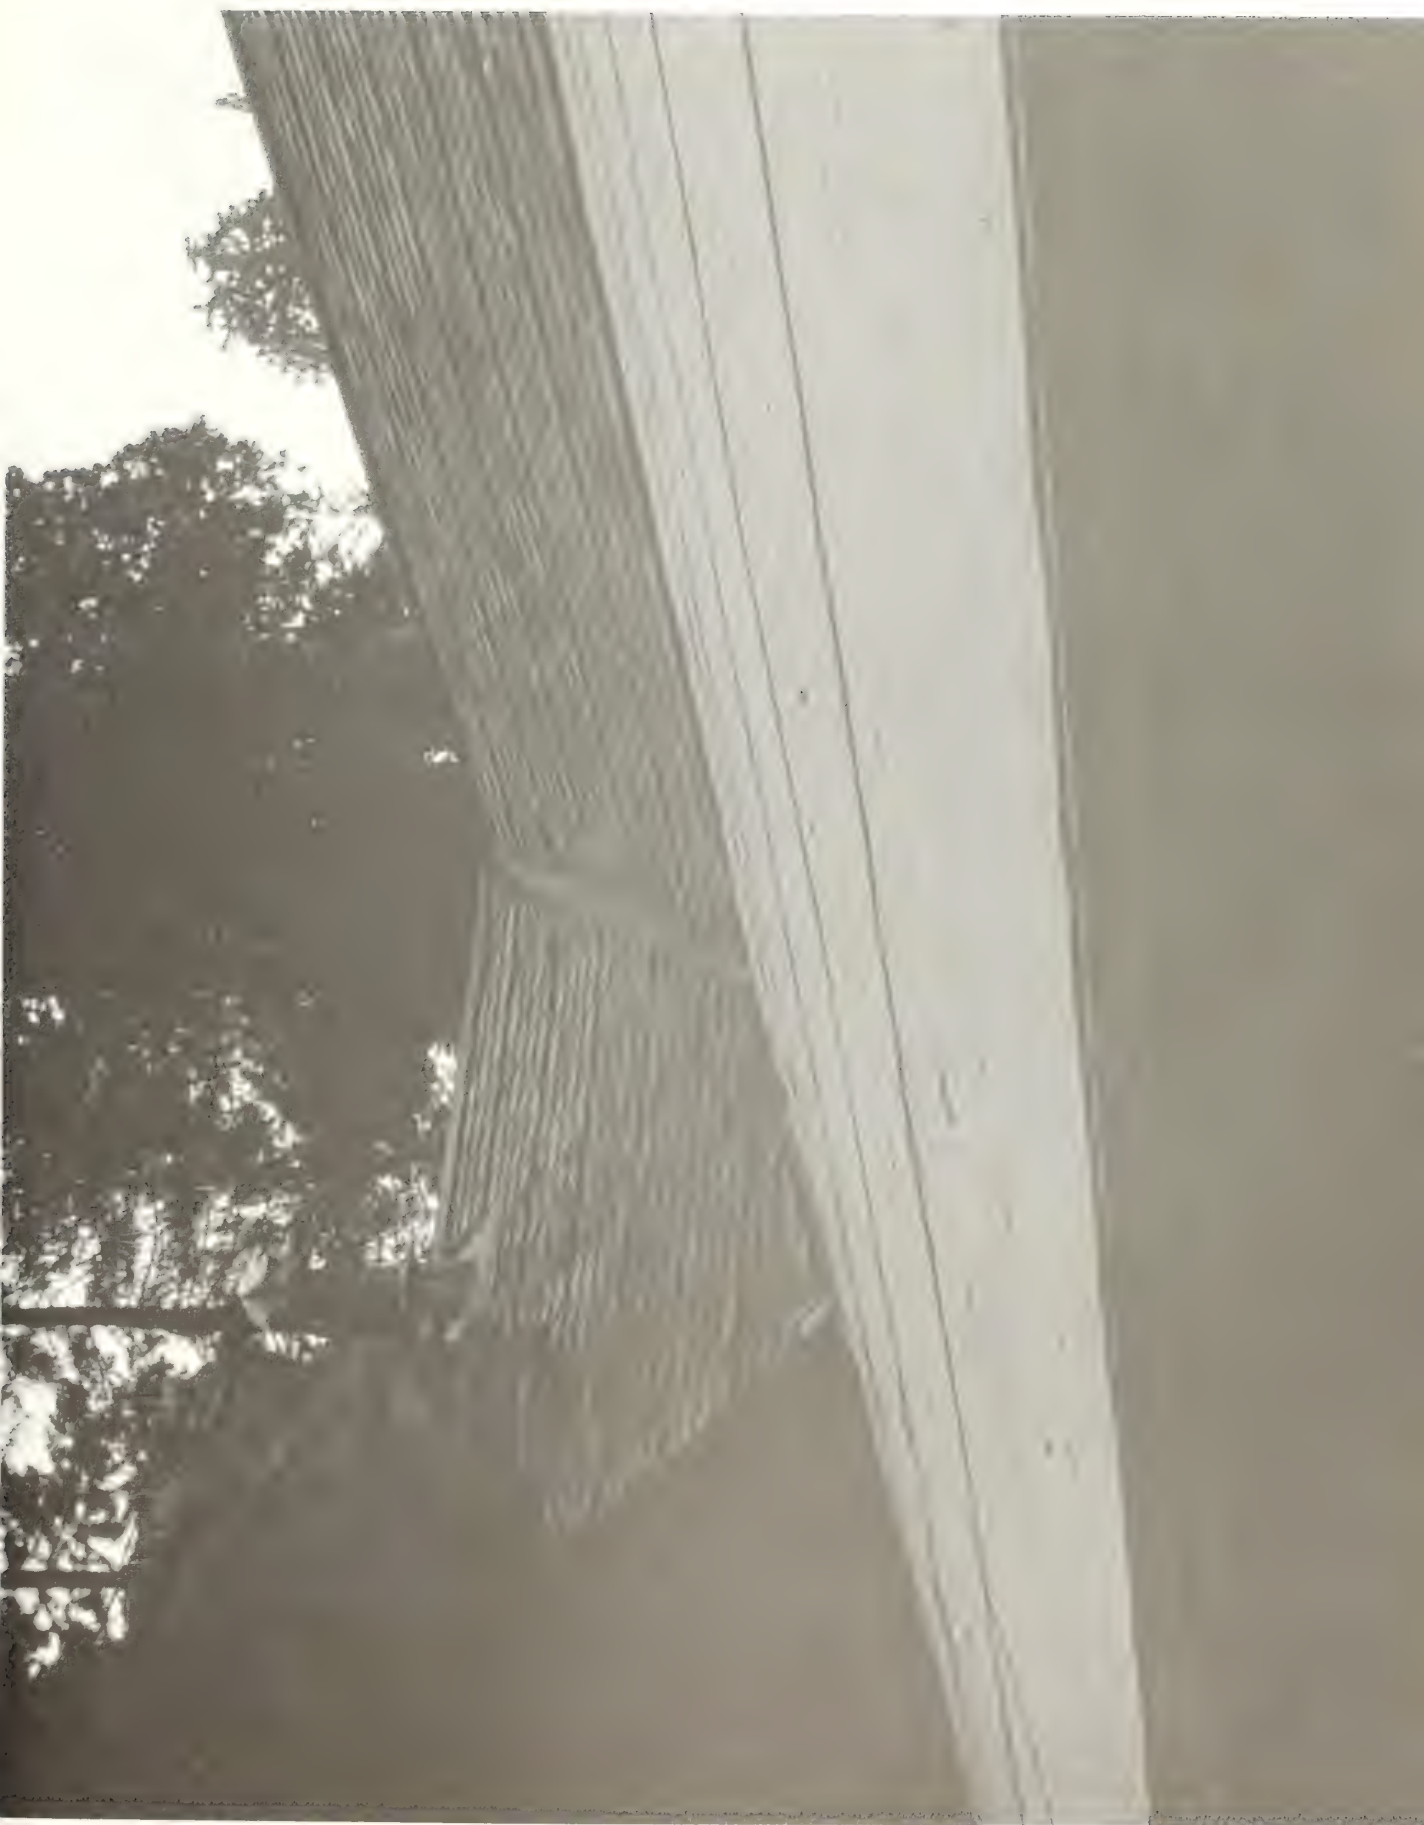
Figure 31. Market Roof Detail (1973). This view shows that the 1938 shed roofed addition had only roll roofing (no shingles). Notice the main market roofing is of wooden shingles which include double shingles at every fifth course. The northern facing leaf of the north wing gable, too, was replaced in this style (Photo not reproduced here). The original shake roof was replaced on these roof leaves. (Photo by Bill Jones, SEQU archive collection)

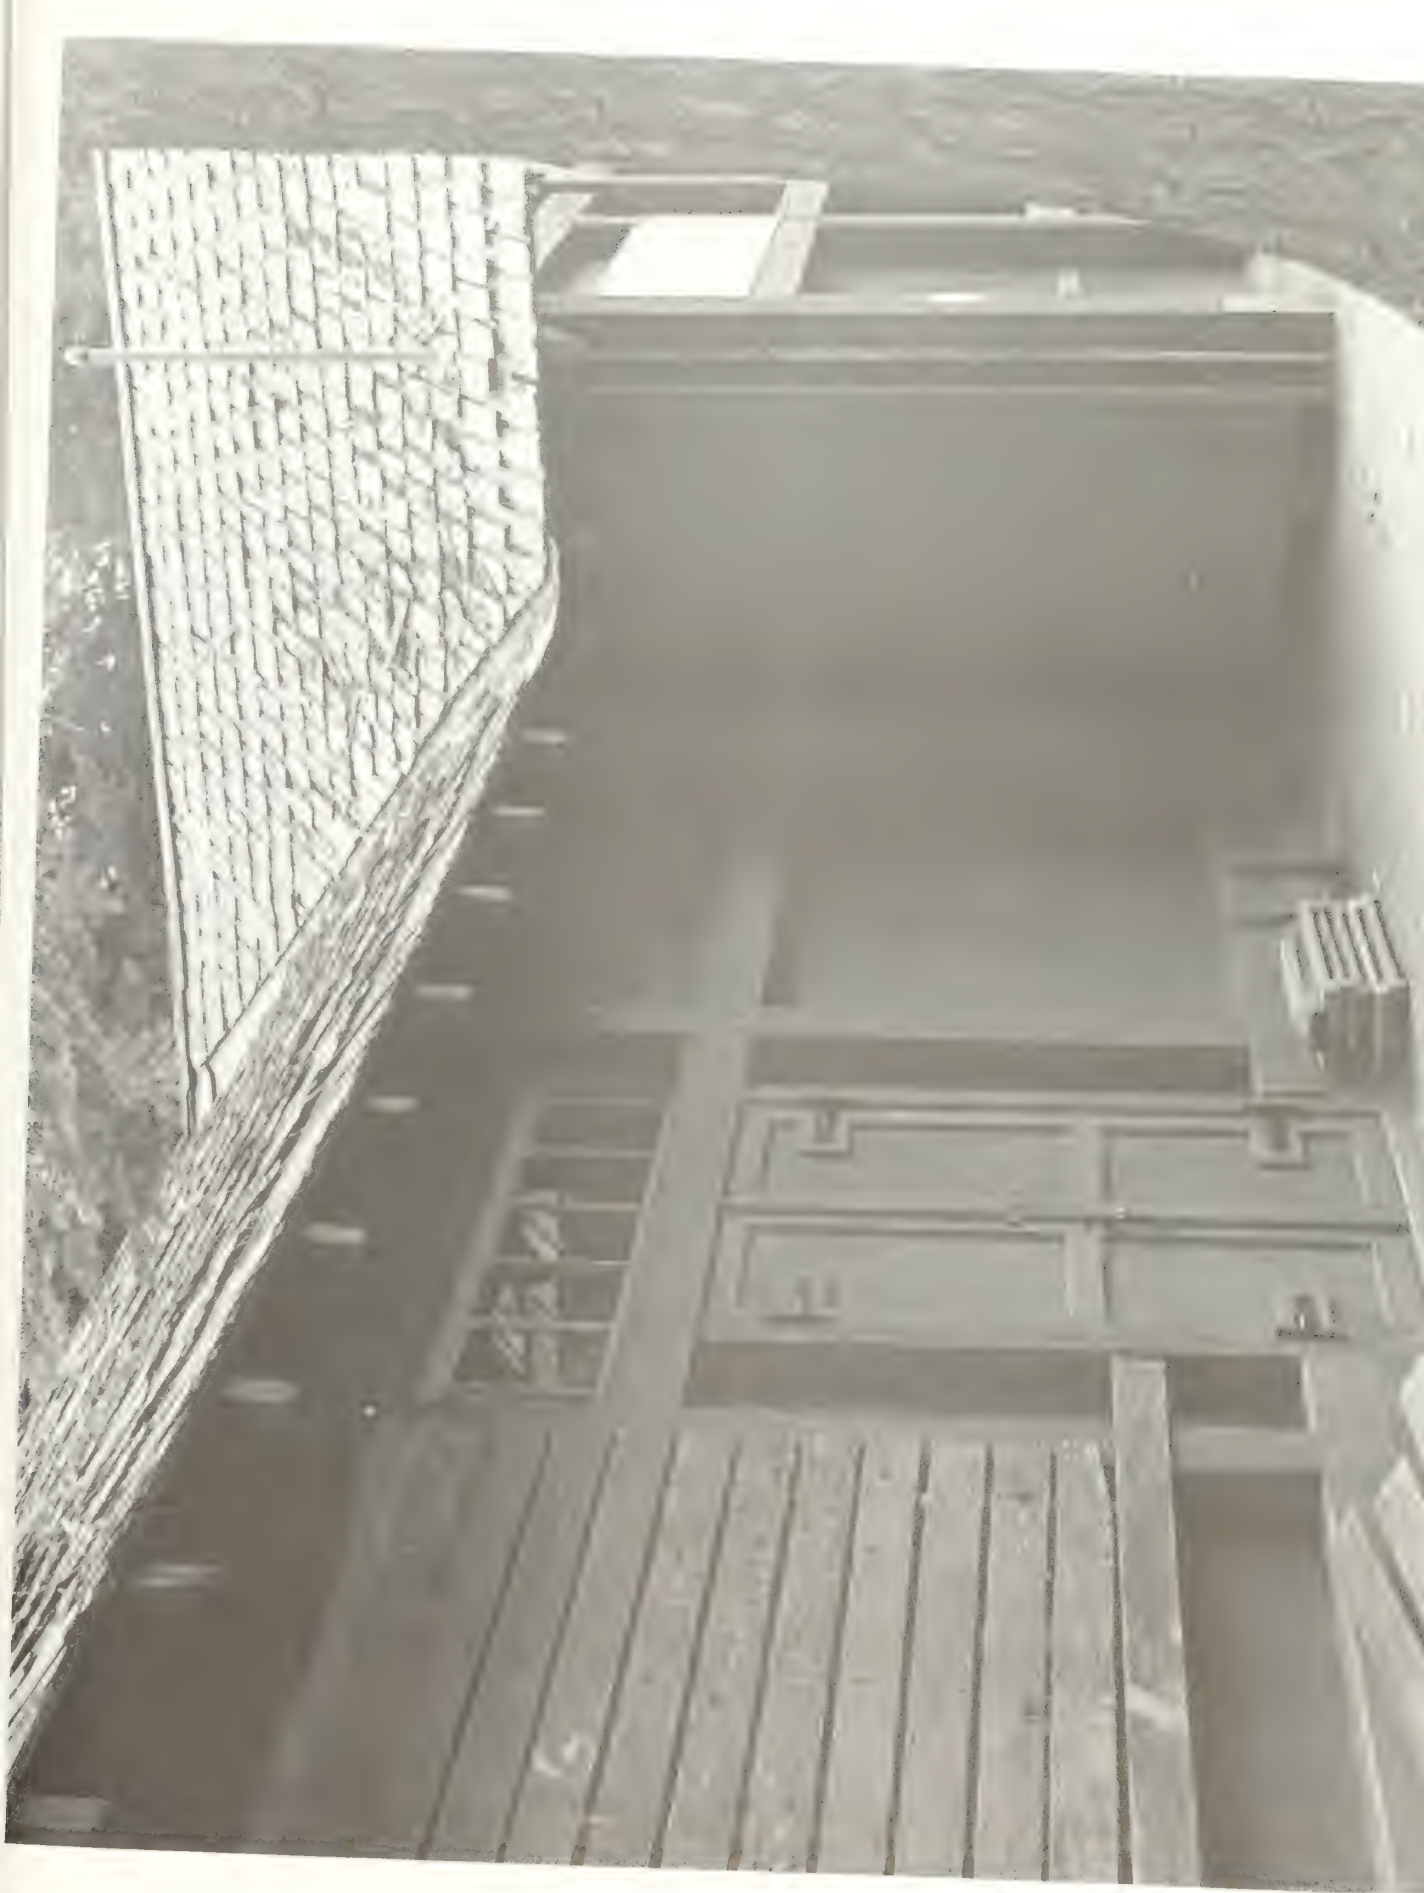
Figure 32. Market Detail at West (1973). The condition and design of the original shake roof is clearly seen here. The gas manifold cabinet, at right, was installed by this period. Notice the present elevation coating of asphalt pavement has yet to be placed and that the crawl space vent is exposed by a depression in the earth walk. (Photo by Bill Jones, SEQU archives collection)

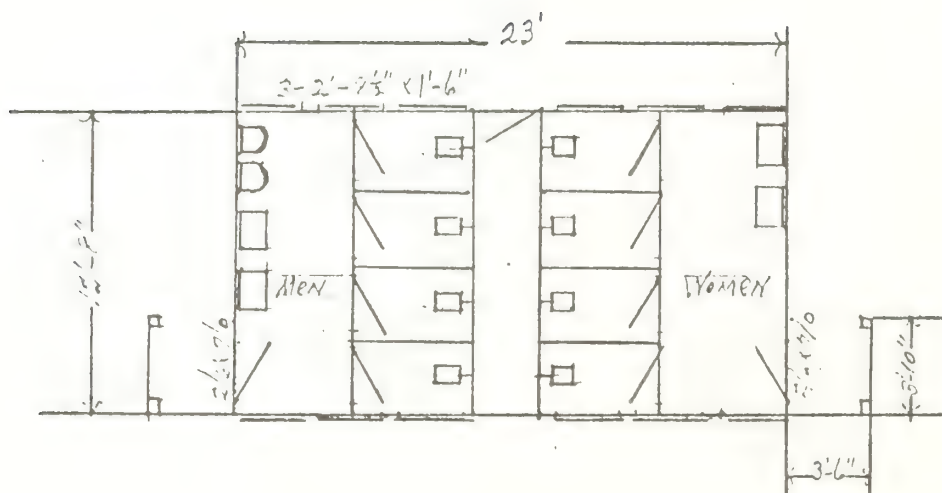
Figure 48. Comfort Station Floor Plan (2/19/51). Notice men's room contains four water closets, two urinals and two lavatories, an arrangement which neither matches original design nor extant conditions.

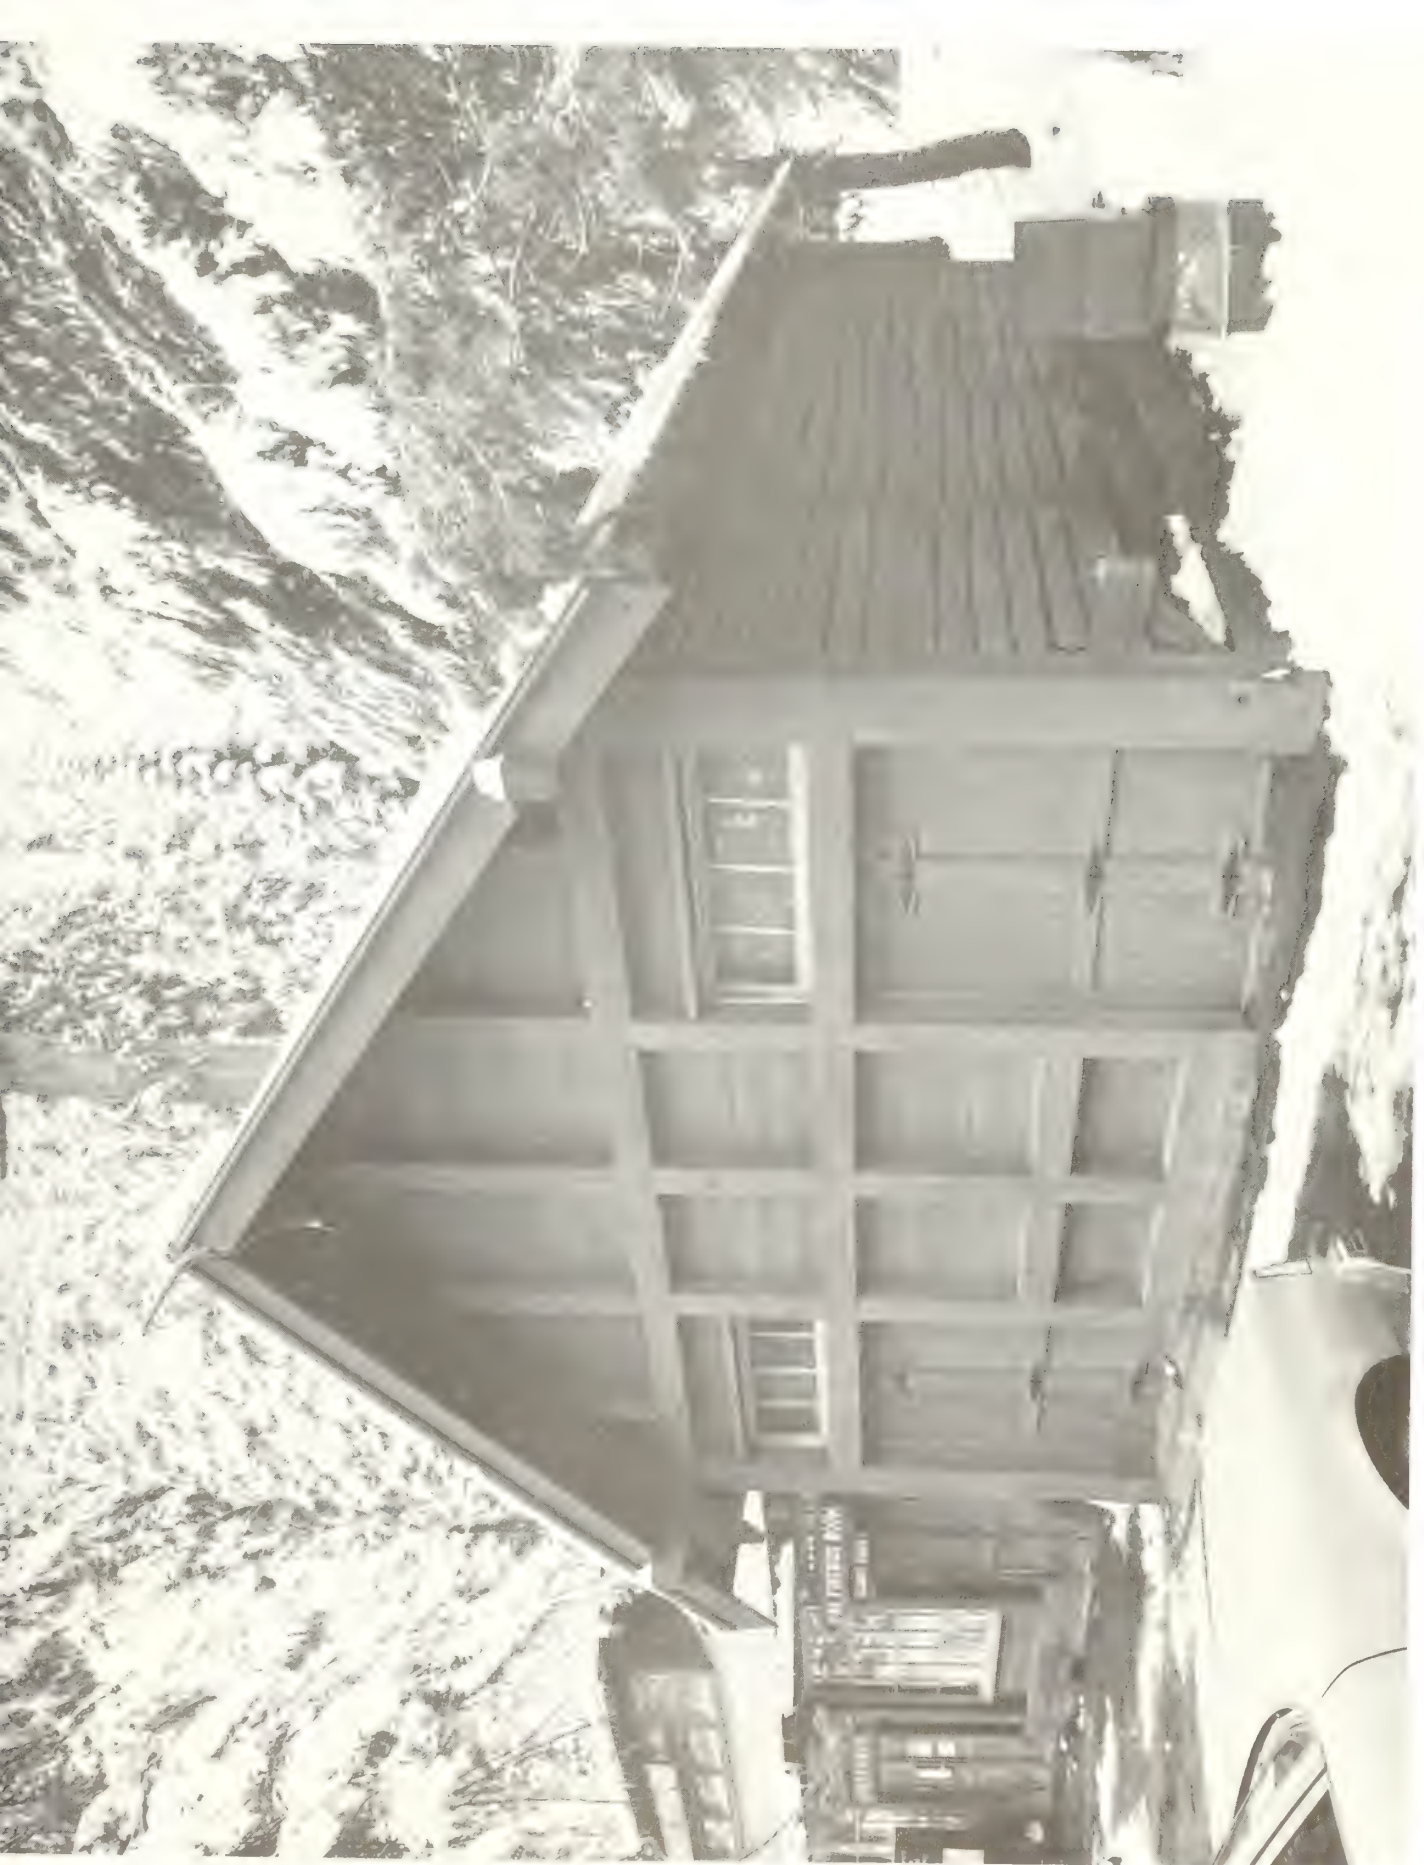
Figure 52. Market, South Wing (ca. 1983). In this winter view of several years ago (prior to the 1983 remodeling of the lounge) boards cover the four large picture windows of the south facade. Neither door in this wing is operable--both are blocked by asphalt at their sills. Notice the doors are center-hinged to fold and open to the full 5 foot width. (HABS #CA2148 B-2)

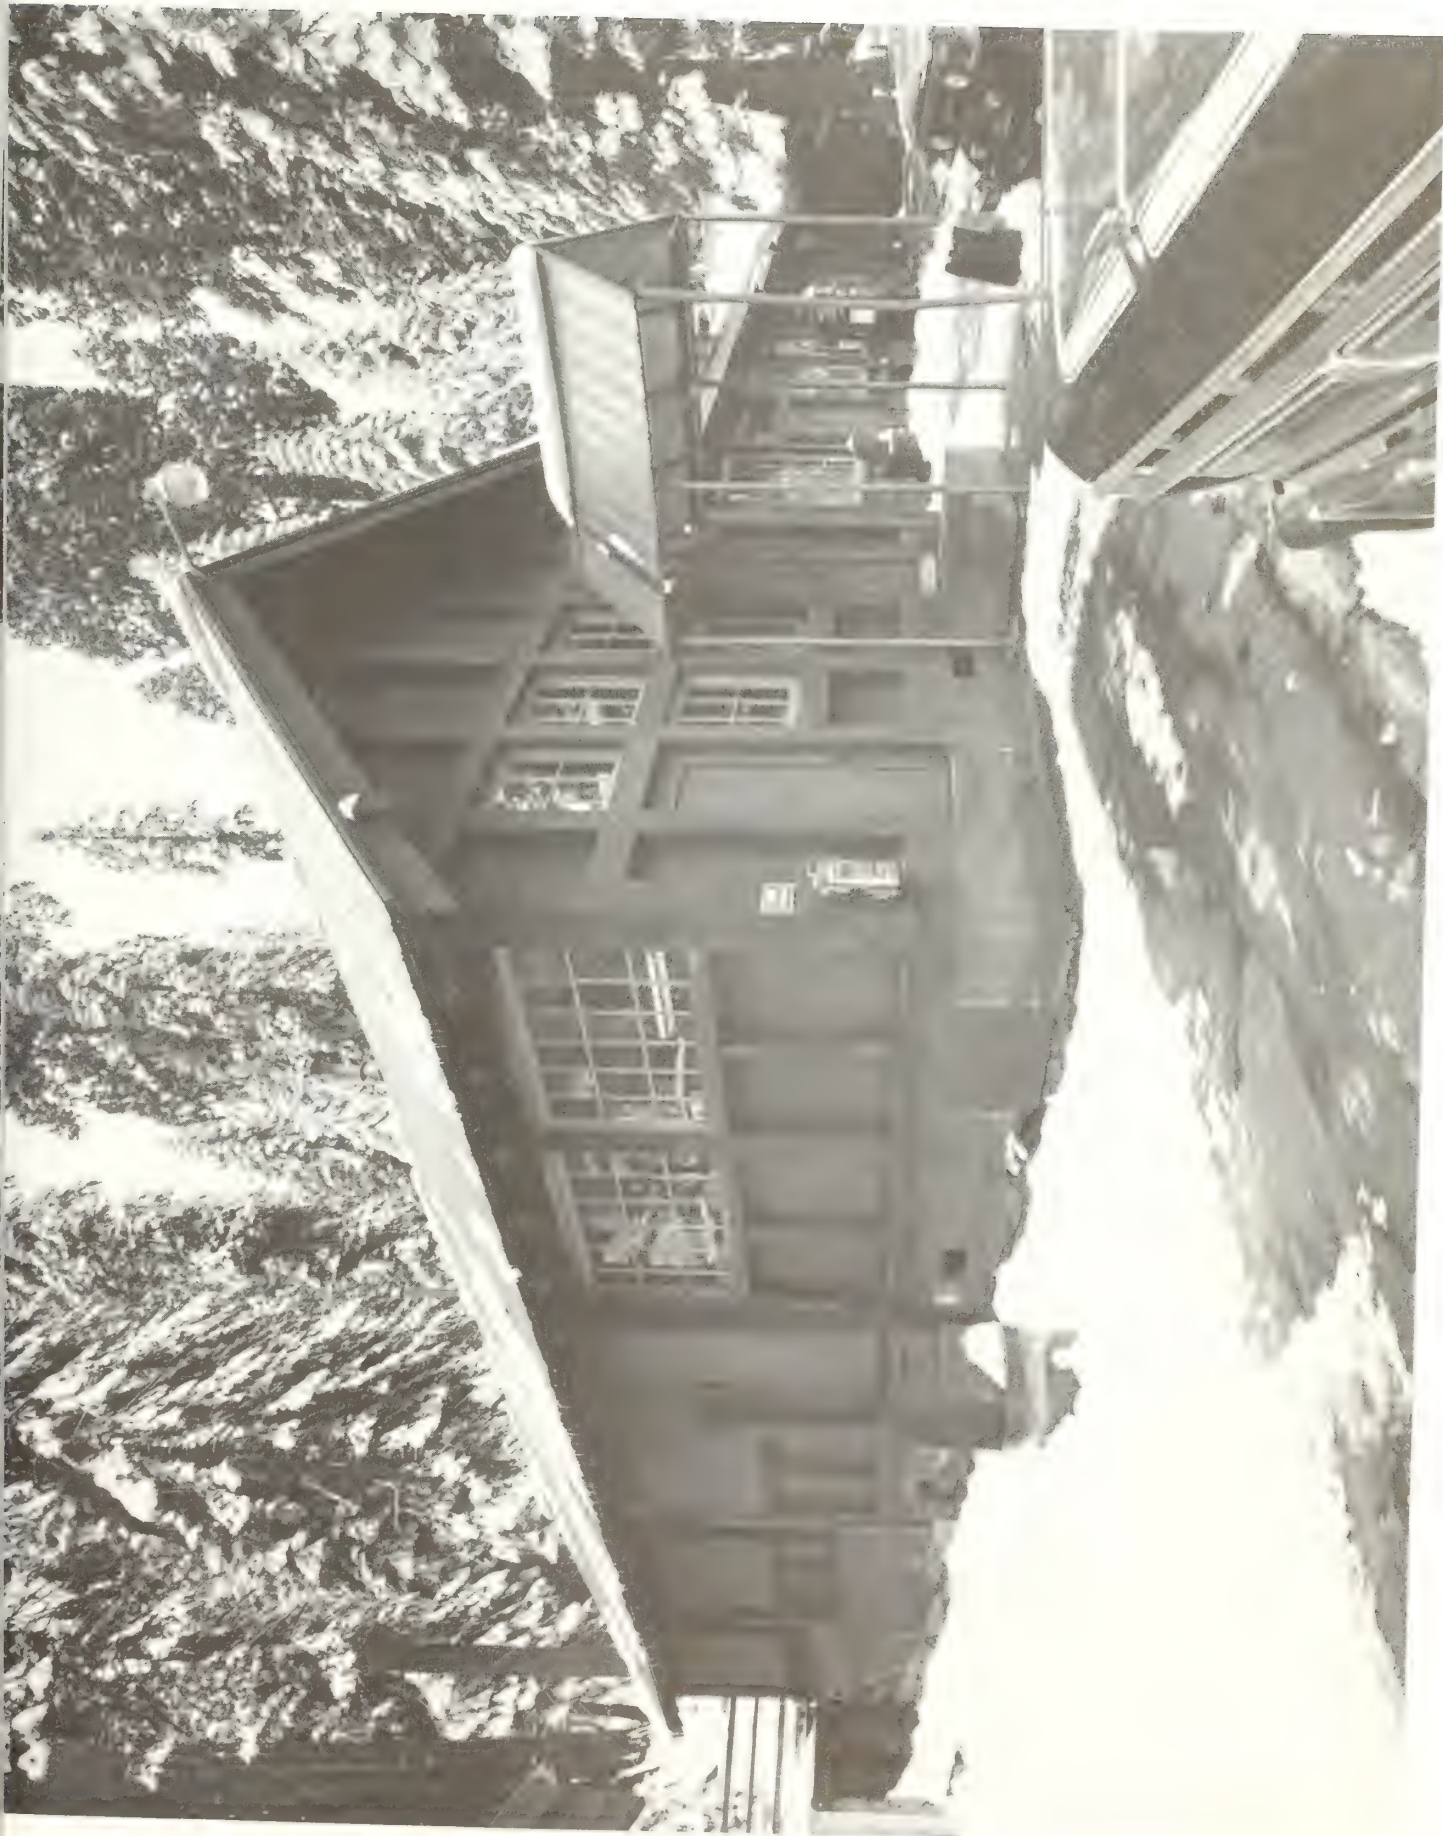
Figure 55. Market, View from North (c. 1983). This photograph provides a clear view of the north facade prior to construction of the existing fence. This view predates the installation of the north wing entry stoop (see figure 53) and, instead, shows a snow canopy protecting the concrete stair entering room 102. The canopy was installed after 1973 and removed about 1984. Note the crawl space vent and crawl space access door. (HABS #CA 2124 B-3).
